**The Immense Cost of Japanese Dams and Dam-Related Landslides and Earthquakes\* [Chinese text available (<http://www.chinadialogue.net/article/show/single/ch/3467-Confronting-the-cost-of-dams-2>)]**

Masano Atsuko

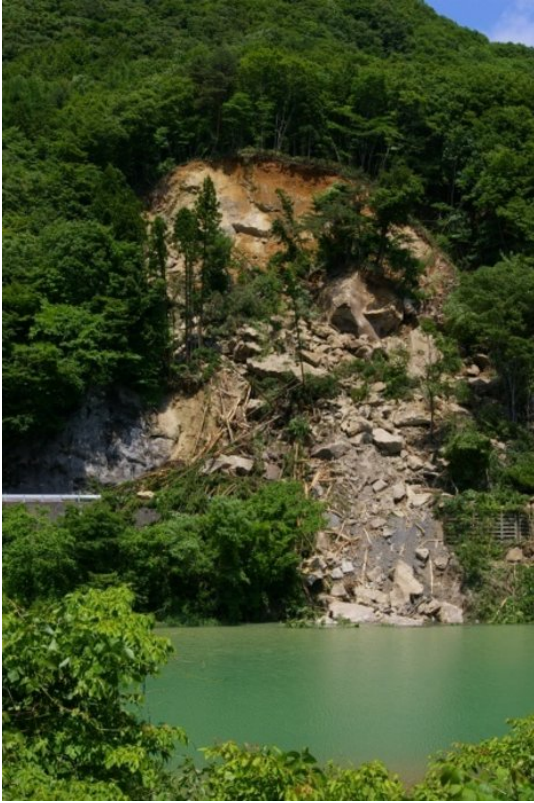
### **The Iwate-Miyagi Nairiku Earthquake**

In this landscape carved by rivers, a landslide with an average depth of 55 meters, a width of 810 meters, and a length of 1400 meters slid as far as 140 meters off the side of the mastiff and into the back of the lake formed by the dam.

A few days after the earthquake, Tokyo University Professor Konagai Kazuo appeared on NHK television's "Close-up Gendai" special, "The Mountain that Disappeared: The Iwate-Miyagi Nairiku Earthquake," and explained that because ground water near the dam was high and because snowmelt had permeated the ground, the violent shaking of the earthquake had caused the massive landslide.

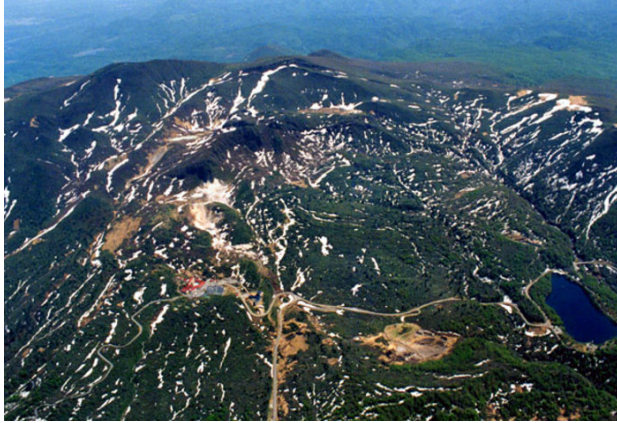
### Mount Kurikoma

According to the Yamaguchi research team, “The soil of the mountain is mainly composed of tuff deposited there some 15 million years ago mixed with some volcanic rock. The peak is a volcanic heap and it is probable that it was susceptible to landslides before the earthquake occurred.” Professor Kaneori explained that tuff, which is consolidated volcanic ash, collapsed easily because it contains many fissures that fill up with water. The geological composition, along with the tremor, led to the massive landslide.

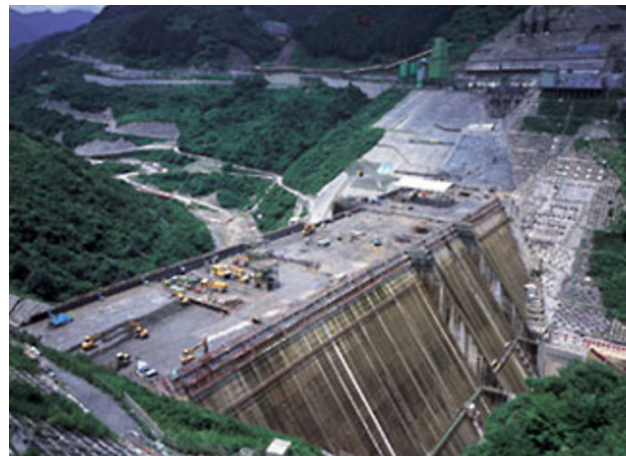
**Takizawa Dam, second construction**

In August 2006, soon after those measures ended, workers began to fill the reservoir again. In May 2007, the slope right next to the one that had been strengthened collapsed when the water level was 16 meters away from being full. A half month later, the slope—now 90 meters wide, 90 feet deep, and 15 meters long—slid further. In response, Kurihara Yoshiharu, the assistant director of the agency announced, “We knew that this was an area susceptible to landslides and while keeping the water level down, we had taken preventive measures such as constructing an embankment.” A visit to the area confirms evidence that the agency had taken all sorts of measures in no less than 40 different places. The agency had “combined the best construction techniques,” said Kurihara, yet this was insufficient.

Prevention measures continued and in August 2007 another attempt was made to fill the reservoir. This time, workers were able to fill it to capacity, but as they began to lower the water in

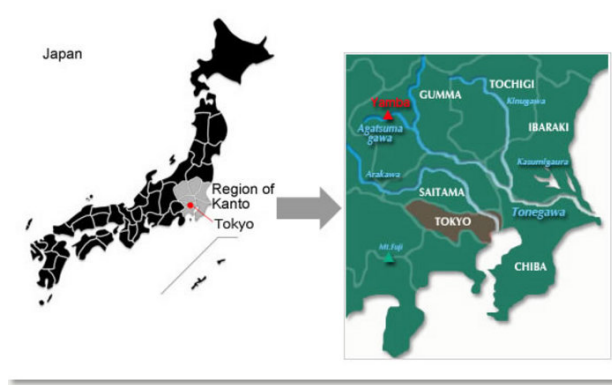
Yamba Dam map

The Transportation Ministry has designated the slopes around the reservoir site as susceptible to landslides and determined that 22 locations are likely to weaken when the reservoir is filled. In the end, however, the ministry decided to take preventive measures in just six spots “where stored water is highly likely to lead to landslides.” The region around the dam has been repeatedly subject to volcanic activity, and, as is even reported on the Transportation Ministry’s website, it is the location of a hydrothermally-altered zone. Areas that have such a zone and experience other volcanic activity are particularly vulnerable to landslides.
