The Immense Cost of Japanese Dams and Dam-Related Landslides and Earthquakes [Chinese text available] ダムと地すべりに浪費される巨費 まさのあつこ

Masano Atsuko

Translated by Aaron Skabelund

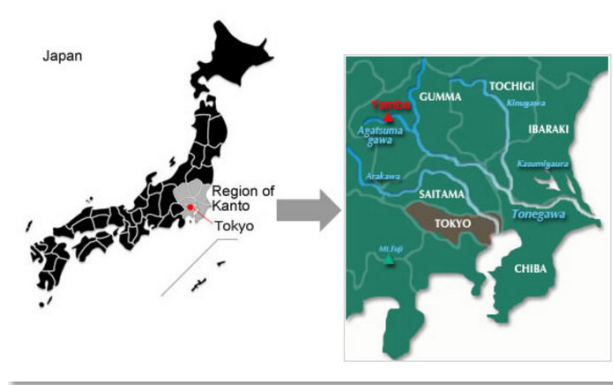
Yamba Dam map

The Transportation Ministry has designated the slopes around the reservoir site as susceptible to landslides and determined that 22 locations are likely to weaken when the reservoir is filled. In the end, however, the ministry decided to take preventive measures in just six spots “where stored water is highly likely to lead to landslides.” The region around the dam has been repeatedly subject to volcanic activity, and, as is even reported on the Transportation Ministry’s website, it is the location of a hydrothermally-altered zone. Areas that have such a zone and experience other volcanic activity are particularly vulnerable to landslides.
