The Immense Cost of Japanese Dams and Dam-Related Landslides and Earthquakes [Chinese text available] ダムと地すべりに浪費される巨費 まさのあつこ

Masano Atsuko

Translated by Aaron Skabelund

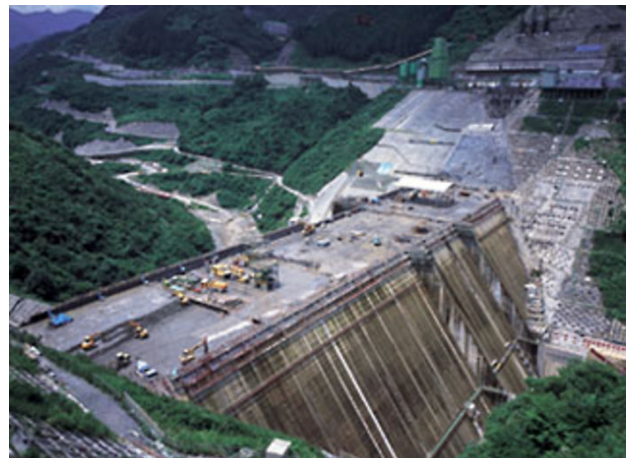
Takizawa Dam, second construction

In August 2006, soon after those measures ended, workers began to fill the reservoir again. In May 2007, the slope right next to the one that had been strengthened collapsed when the water level was 16 meters away from being full. A half month later, the slope—now 90 meters wide, 90 feet deep, and 15 meters long—slid further. In response, Kurihara Yoshiharu, the assistant director of the agency announced, “We knew that this was an area susceptible to landslides and while keeping the water level down, we had taken preventive measures such as constructing an embankment.” A visit to the area confirms evidence that the agency had taken all sorts of measures in no less than 40 different places. The agency had “combined the best construction techniques,” said Kurihara, yet this was insufficient.

Prevention measures continued and in August 2007 another attempt was made to fill the reservoir. This time, workers were able to fill it to capacity, but as they began to lower the water in

April 2008, a crack was discovered in a city road near the reservoir bank. As the water continued to be lowered, other fissures appeared. On 7 May, a 40 centimeter diameter crack was found on Route 140 on the other side of the reservoir and six days later another was discovered in a concrete barrier. Even when the water level was maintained, the land continued to slump. On 13 June, a crack appeared in another city road as the slope dropped by .4 meters. When I visited Saitama, a worker put it bluntly: “A mountain is moving here.” It was an obvious disaster.
