The Immense Cost of Japanese Dams and Dam-Related Landslides and Earthquakes [Chinese text available] ダムと地すべりに浪費される巨費 まさのあつこ

Masano Atsuko

Translated by Aaron Skabelund

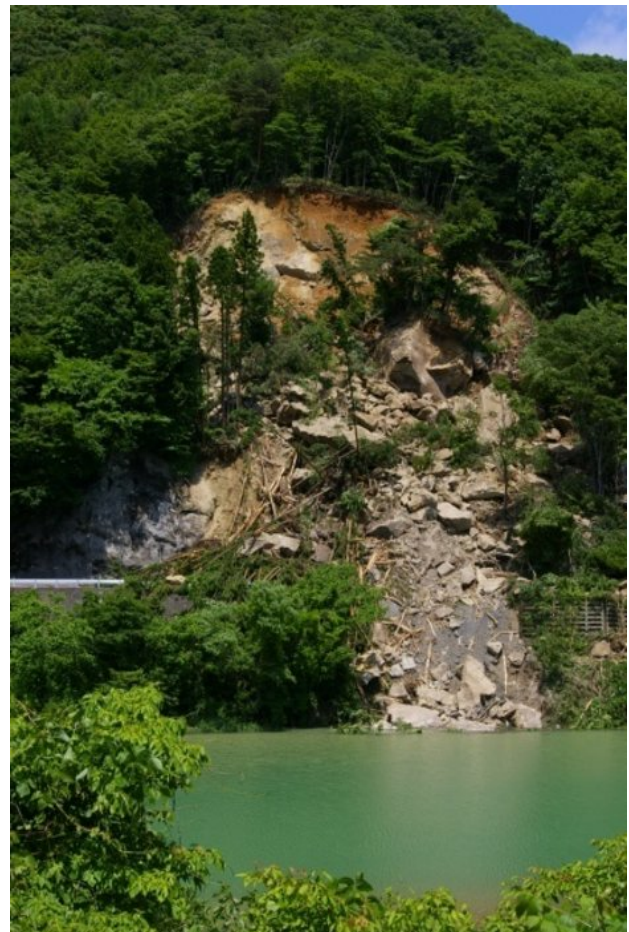
The Iwate-Miyagi Nairiku Earthquake

It had been three months since the Iwate-Miyagi Nairiku Earthquake struck northern Honshu on 14 June 2008, triggering a huge landslide above Aratozawa Dam. The area hit by a landslide has been further carved by snow and rain, and trees and other vegetation are in disarray. The site looks like the day after a wretched barber had just given it a bad haircut. For the earth, this must be an embarrassing appearance.

In this landscape carved by rivers, a landslide with an average depth of 55 meters, a width of 810 meters, and a length of 1400 meters slid as far as 140 meters off the side of the mastiff and into the back of the lake formed by the dam.

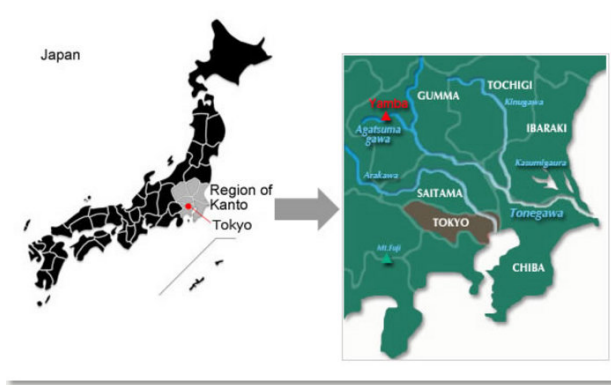
Yamba Dam map

The Transportation Ministry has designated the slopes around the reservoir site as susceptible to landslides and determined that 22 locations are likely to weaken when the reservoir is filled. In the end, however, the ministry decided to take preventive measures in just six spots “where stored water is highly likely to lead to landslides.” The region around the dam has been repeatedly subject to volcanic activity, and, as is even reported on the Transportation Ministry’s website, it is the location of a hydrothermally-altered zone. Areas that have such a zone and experience other volcanic activity are particularly vulnerable to landslides.
