The Immense Cost of Japanese Dams and Dam-Related Landslides and Earthquakes [Chinese text available] ダムと地すべりに浪費される巨費 まさのあつこ

Masano Atsuko

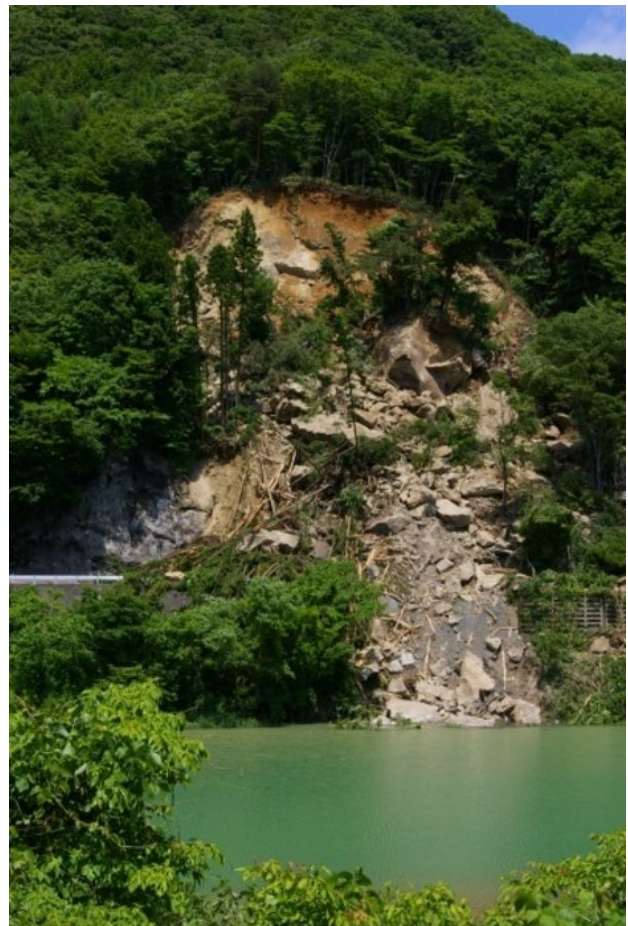
The Iwate-Miyagi Nairiku Earthquake

In this landscape carved by rivers, a landslide with an average depth of 55 meters, a width of 810 meters, and a length of 1400 meters slid as far as 140 meters off the side of the mastiff and into the back of the lake formed by the dam.

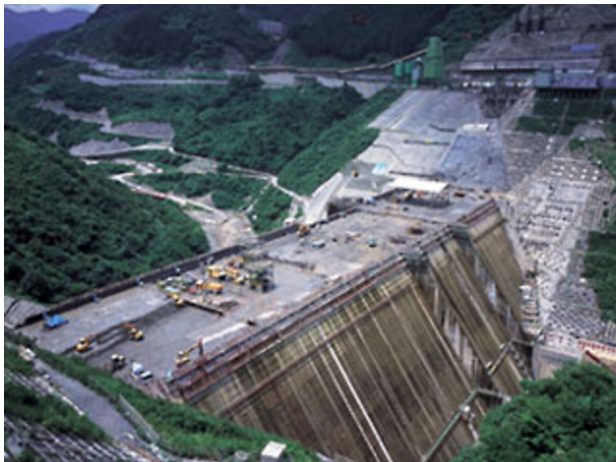
Takizawa Dam, second construction

the water level was 16 meters away from being full. A half month later, the slope—now 90 meters wide, 90 feet deep, and 15 meters long—slid further. In response, Kurihara Yoshiharu, the assistant director of the agency announced, “We knew that this was an area susceptible to landslides and while keeping the water level down, we had taken preventive measures such as constructing an embankment.” A visit to the area confirms evidence that the agency had taken all sorts of measures in no less than 40 different places. The agency had “combined the best construction techniques,” said Kurihara, yet this was insufficient.

Prevention measures continued and in August 2007 another attempt was made to fill the reservoir. This time, workers were able to fill it to capacity, but as they began to lower the water in April 2008, a crack was discovered in a city road near the reservoir bank. As the water continued to be lowered, other fissures appeared. On 7 May, a 40 centimeter diameter crack was found on Route 140 on the other side of the reservoir and six days later another was discovered in a concrete barrier. Even when the water level was maintained, the land continued to slump. On 13 June, a crack appeared in another city road as the slope dropped by .4 meters. When I visited Saitama,

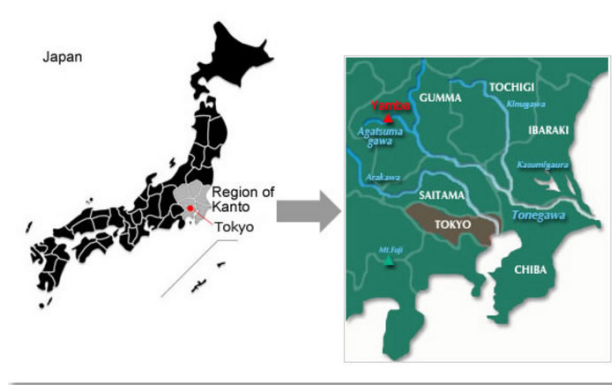
Yamba Dam map

The Transportation Ministry has designated the slopes around the reservoir site as susceptible to landslides and determined that 22 locations are likely to weaken when the reservoir is filled. In the end, however, the ministry decided to take preventive measures in just six spots “where stored water is highly likely to lead to landslides.” The region around the dam has been repeatedly subject to volcanic activity, and, as is even reported on the Transportation Ministry’s website, it is the location of a hydrothermally-altered zone. Areas that have such a zone and experience other volcanic activity are particularly vulnerable to landslides.
