The Immense Cost of Japanese Dams and Dam-Related Landslides and Earthquakes [Chinese text available] ダムと地すべりに浪費される巨費 まさのあつこ

Masano Atsuko

The Immense Cost of Japanese Dams and Dam-Related Landslides and Earthquakes* [Chinese text available (<http://www.chinadialogue.net/article/show/single/ch/3467-Confronting-the-cost-of-dams-2>)]

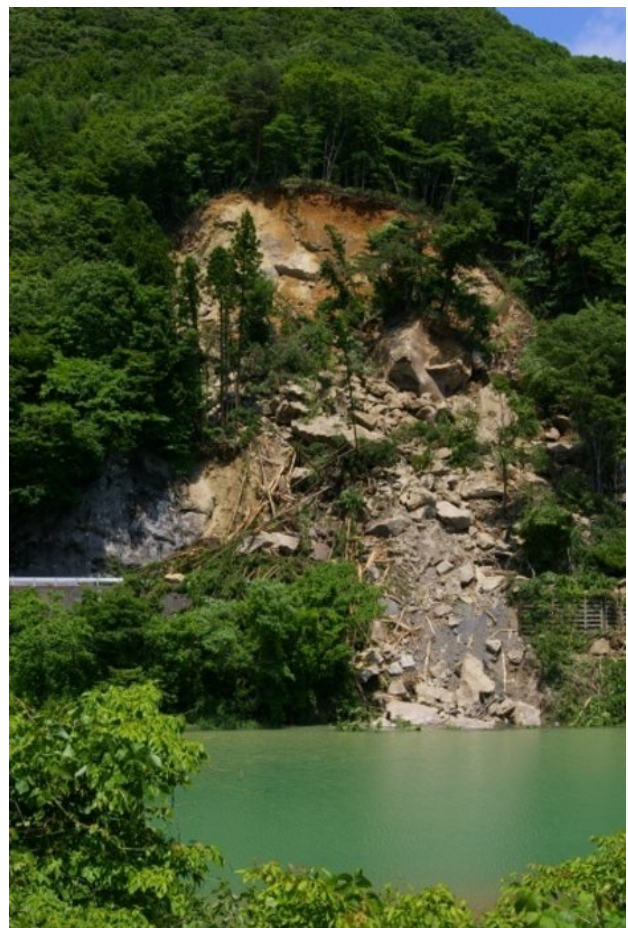
The Iwate-Miyagi Nairiku Earthquake

In this landscape carved by rivers, a landslide with an average depth of 55 meters, a width of 810 meters, and a length of 1400 meters slid as far as 140 meters off the side of the mastiff and into the back of the lake formed by the dam.

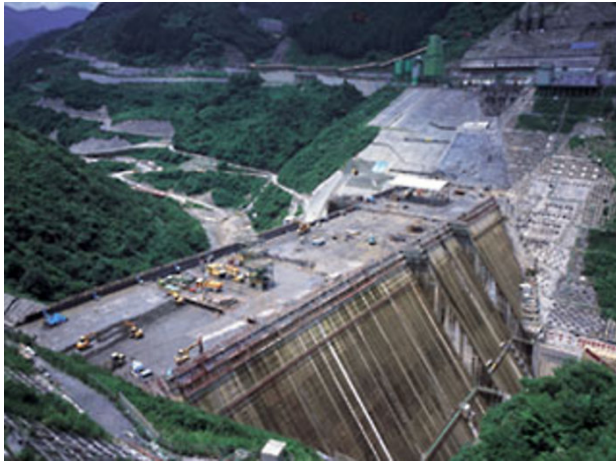
Takizawa Dam, second construction

the water level was 16 meters away from being full. A half month later, the slope—now 90 meters wide, 90 feet deep, and 15 meters long—slid further. In response, Kurihara Yoshiharu, the assistant director of the agency announced, “We knew that this was an area susceptible to landslides and while keeping the water level down, we had taken preventive measures such as constructing an embankment.” A visit to the area confirms evidence that the agency had taken all sorts of measures in no less than 40 different places. The agency had “combined the best construction techniques,” said Kurihara, yet this was insufficient.

Prevention measures continued and in August 2007 another attempt was made to fill the reservoir. This time, workers were able to fill it to capacity, but as they began to lower the water in April 2008, a crack was discovered in a city road near the reservoir bank. As the water continued to be lowered, other fissures appeared. On 7 May, a 40 centimeter diameter crack was found on Route 140 on the other side of the reservoir and six days later another was discovered in a concrete barrier. Even when the water level was maintained, the land continued to slump. On 13 June, a crack appeared in another city road as the slope dropped by .4 meters. When I visited Saitama,
