**The Immense Cost of Japanese Dams and Dam-Related Landslides and Earthquakes\* [Chinese text available (<http://www.chinadialogue.net/article/show/single/ch/3467-Confronting-the-cost-of-dams-2>)]**

Masano Atsuko

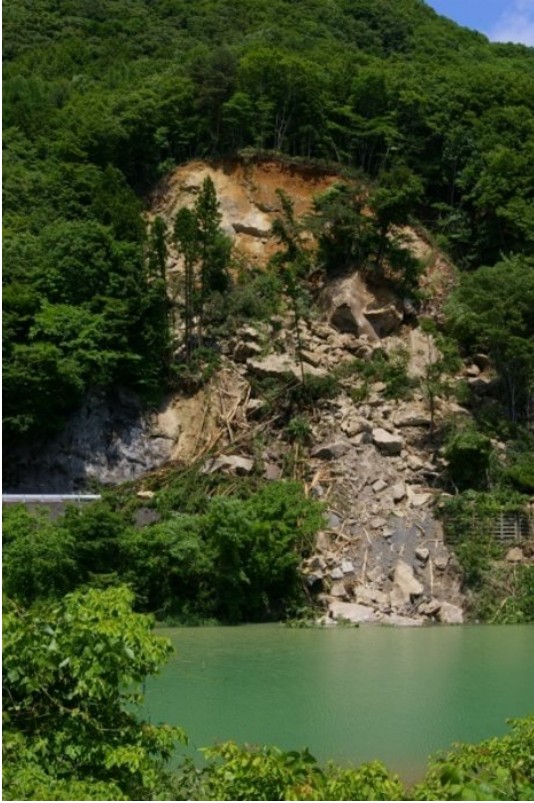
### **The Iwate-Miyagi Nairiku Earthquake**

In this landscape carved by rivers, a landslide with an average depth of 55 meters, a width of 810 meters, and a length of 1400 meters slid as far as 140 meters off the side of the mastiff and into the back of the lake formed by the dam.

A few days after the earthquake, Tokyo University Professor Konagai Kazuo appeared on NHK television's "Close-up Gendai" special, "The Mountain that Disappeared: The Iwate-Miyagi Nairiku Earthquake," and explained that because ground water near the dam was high and because snowmelt had permeated the ground, the violent shaking of the earthquake had caused the massive landslide.

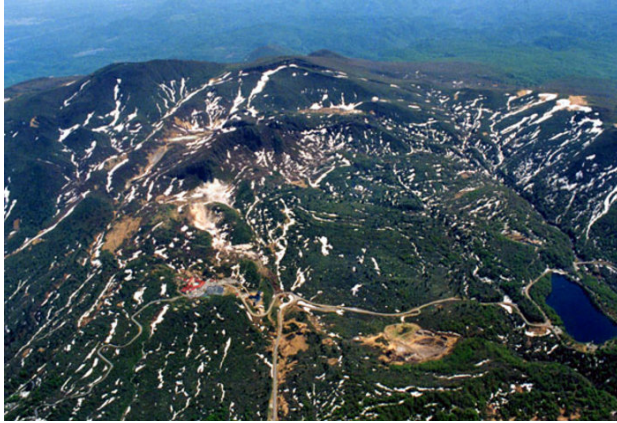
### Mount Kurikoma

According to the Yamaguchi research team, “The soil of the mountain is mainly composed of tuff deposited there some 15 million years ago mixed with some volcanic rock. The peak is a volcanic heap and it is probable that it was susceptible to landslides before the earthquake occurred.” Professor Kaneori explained that tuff, which is consolidated volcanic ash, collapsed easily because it contains many fissures that fill up with water. The geological composition, along with the tremor, led to the massive landslide.

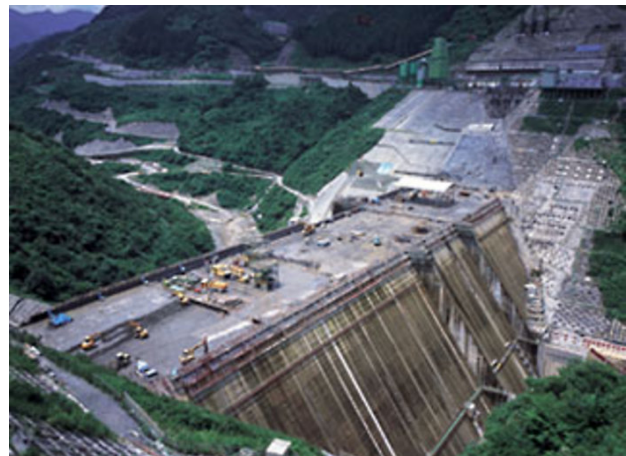
**Takizawa Dam, second construction**

In August 2006, soon after those measures ended, workers began to fill the reservoir again. In May 2007, the slope right next to the one that had been strengthened collapsed when the water level was 16 meters away from being full. A half month later, the slope—now 90 meters wide, 90 feet deep, and 15 meters long—slid further. In response, Kurihara Yoshiharu, the assistant director of the agency announced, “We knew that this was an area susceptible to landslides and while keeping the water level down, we had taken preventive measures such as constructing an embankment.” A visit to the area confirms evidence that the agency had taken all sorts of measures in no less than 40 different places. The agency had “combined the best construction techniques,” said Kurihara, yet this was insufficient.

Prevention measures continued and in August 2007 another attempt was made to fill the reservoir. This time, workers were able to fill it to capacity, but as they began to lower the water in

April 2008, a crack was discovered in a city road near the reservoir bank. As the water continued to be lowered, other fissures appeared. On 7 May, a 40 centimeter diameter crack was found on Route 140 on the other side of the reservoir and six days later another was discovered in a concrete barrier. Even when the water level was maintained, the land continued to slump. On 13 June, a crack appeared in another city road as the slope dropped by .4 meters. When I visited Saitama, a worker put it bluntly: “A mountain is moving here.” It was an obvious disaster.

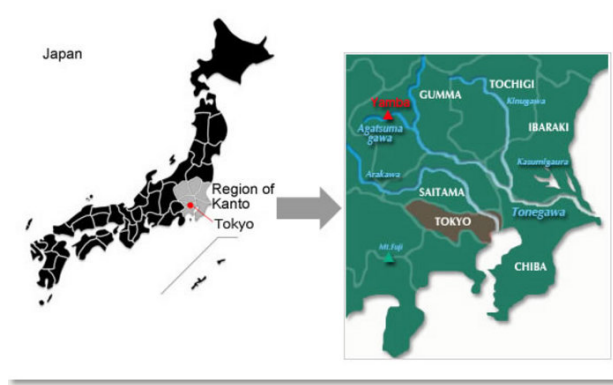
**Yamba Dam map**

The Transportation Ministry has designated the slopes around the reservoir site as susceptible to landslides and determined that 22 locations are likely to weaken when the reservoir is filled. In the end, however, the ministry decided to take preventive measures in just six spots “where stored water is highly likely to lead to landslides.” The region around the dam has been repeatedly subject to volcanic activity, and, as is even reported on the Transportation Ministry’s website, it is the location of a hydrothermally-altered zone. Areas that have such a zone and experience other volcanic activity are particularly vulnerable to landslides.
